**Flood Control Project Maintenance
Levee Inspections**

Spring 2015 Levee Inspection Results

Yolo County Service Area 6

Waterway			Bank	Unit Miles
Unit No. 01 Right Bank of Sacramento River at Knights Landing			Right	5.87
	Spring (March - May)	Summer (June - August)	(September - November) Fall	Winter (December - February)
Unit Maintenance Rating (Fall Only)				
Date of Inspection	05/26/2015 - 05/26/2015			
DWR Inspector	Jai Lor			
Accompanied By	Chris Starke Yolo County

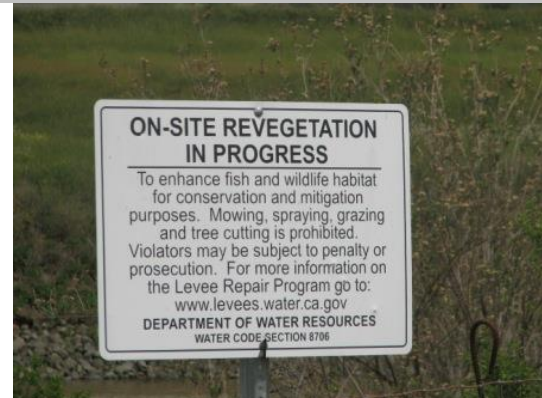
Photo 1 of 3 : SP_2015_NA0022_350_36_20150401_00038.jpg

LM Start	4.25	Rating **	A/W	Issue No.	36
LM End	4.49	Issue Type +	Ma	Location *	WS
Category	Earthen Levee			GPS Latitude/Longitude	
				Start	End
Item	Vegetation			38.767125 °	38.764582 °
				-121.693267 °	-121.690285 °
DWR ID	DWR_NA0022_01_s _ 2012_36				
Action/Comments					
Environmental Requirements.

USACE revegetation site photo spring 2012.

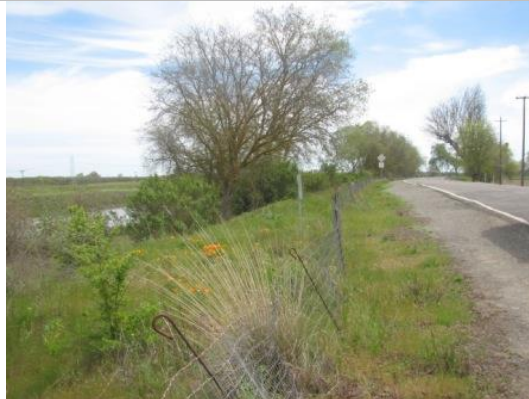
Photo 2 of 3 : SP_2015_NA0022_350_36_20150401_00039.jpg

LM Start	4.25	Rating **	A/W	Issue No.	36 (cont)	
LM End	4.49	Issue Type +	Ma	Location *	WS	
Category	Earthen Levee			GPS Latitude/Longitude		
				Start		End
Item	Vegetation			38.767125 °		38.764582 °
				-121.693267 °		-121.690285 °
DWR ID	DWR_NA0022_01_s _ 2012_36					
Action/Comments						
Environmental Requirements.

Another view of the site.

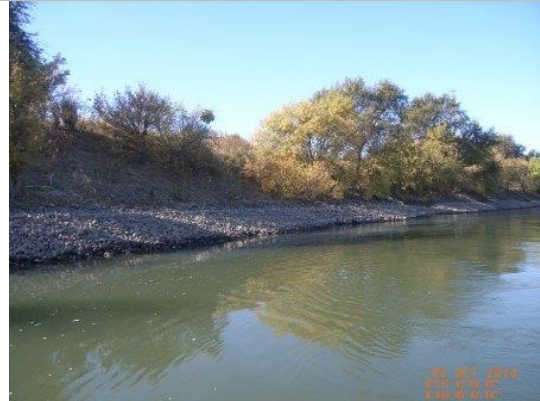
Photo 1 of 1 : SP_2015_NA0022_350_4_20150401_00006.jpg

LM Start	4.66	Rating **	M	Issue No.	4
LM End	4.86	Issue Type +	Ma	Location *	WS
Category	Supplemental			GPS Latitude/Longitude	
				Start	End
Item	USACE Erosion Survey			38.763486 °	38.763313 °
				-121.687567 °	-121.684038 °
DWR ID	DWR_NA0022_01_f_2014_4				
Action/Comments					
Inspector Comments: 2009 - Erosion into the levee toe. Some cobbles have been dumped into the erosion pockets. 2010 - Old cobble site starting to unravel. 2012 - Slope continues to steepen and new animal holes. 2013: Downstream cobble is unraveling. [2013 Site ID: SAC_85-4_R]

USACE 2013 Photo #1

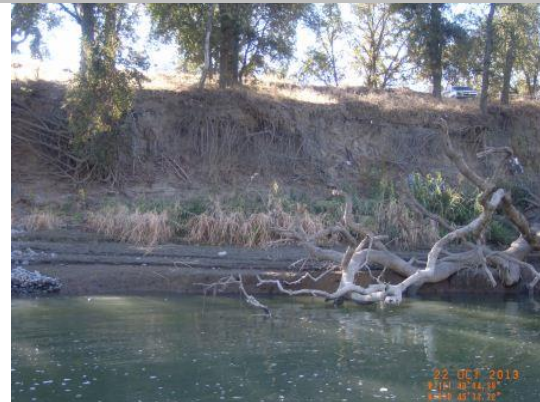
Photo 1 of 3 : SP_2015_NA0022_350_3_20150401_00003.jpg

LM Start	5.78	Rating **	M	Issue No.	3
LM End	5.86	Issue Type +	Ma	Location *	WS
Category	Supplemental			GPS Latitude/Longitude	
				Start	End
Item	USACE Erosion Survey			38.758877 °	38.759390 °
				-121.669365 °	-121.667500 °
DWR ID	DWR_NA0022_01_f_2014_3				
Action/Comments					
Inspector Comments: 2006 - Approximately 18 to 20 ft of bank near levee at the corner of the levee and the Freemont Weir. Vertical bank with undercutting/mass failure. 2007 - Staked at top of bank for monitoring. 2011 - Site has become significantly worse with more of the toe and lower bank eroded. Many trees have fallen since last year. 2012 - Site looks worse with more erosion around trees. 2013: Additional erosion into toe. [2013 Site ID: SAC 83-9 R]

USACE 2013 Photo #1

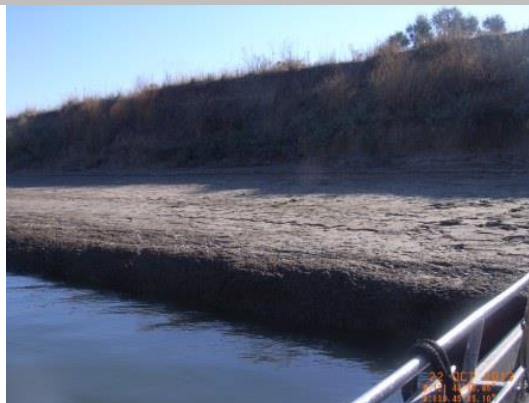
Photo 3 of 3 : SP_2015_NA0022_350_3_20150401_00005.jpg

LM Start	5.78	Rating **	M	Issue No.	3 (cont)
LM End	5.86	Issue Type +	Ma	Location *	WS

USACE 2013 Photo #3
